ZONE 4 The French Quarter

The Hoi An Historical Museum

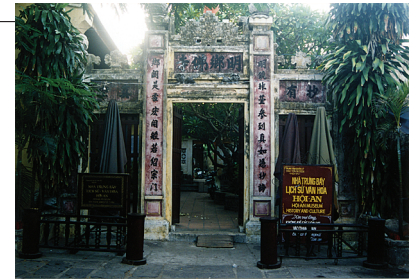
1

We suggest starting your tour at the Hoi An Historical Museum, Nguyen Hue 1. Before starting your journey across the city, a tour around its exhibition halls will definitely worth while in order to gain valuable information about Hoi An's past. Originally, this building was founded as the Quan Am Temple. In olden times it became an important place of worship for the people who escaped from war-torn China at that time and formed a settlement called "Ming Go(明郷)" in Hoi An. The buildings are constructed according to traditional Chinese style.

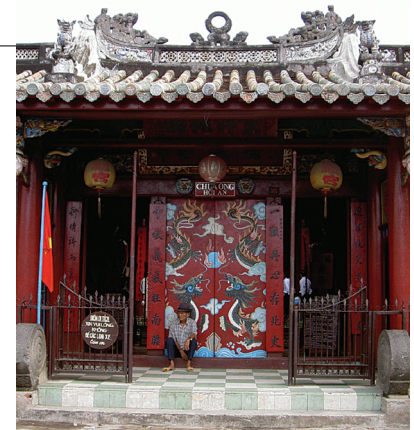
2

Next to the museum is the Quan Cong temple, which is dedicated to Quan Cong, one of the heroes of the famous Chinese historical novel the "Three Nations". This temple founded in 1653, was connected to the former Chinese quarter. Nowadays, stands across the market showing its colourful facade.

The present building is a reconstruction from the 19th century. As you can see the roof framework was built in traditional Chinese style.

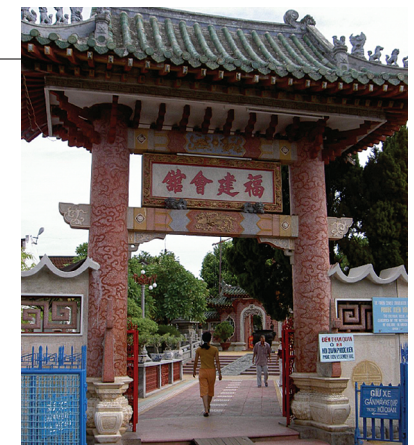
3

The Fukien Assembly Hall is the largest and oldest hall in Hoi An. This Assembly Hall was founded as the Kim Son temple in 1697. Later, in 1792, it was transformed into the Fukien Assembly Hall.

The main building is located behind Tran Phu Street. The orientation of the hall is different from the other surrounding buildings. It is said that its axis points to the Chayo-mountain, which catches the energy flowing from the Assembly Hall.

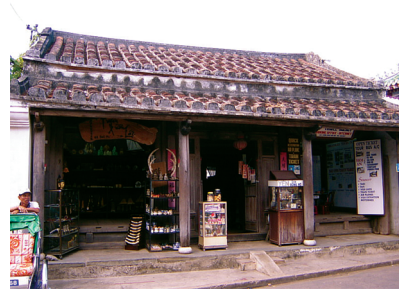
This house, restored in 1999, was externally in relative good condition. However, most of the interior main beams were suffering from extensive termite damage. Therefore, the house was first taken apart and then reconstructed. The floors on both sides of the front area were refurbished after finding the mortises on the columns that supported the floor beams. Under the eaves, there is detachable display board that put in place when the shop open.

Before restoration 修復前の状態

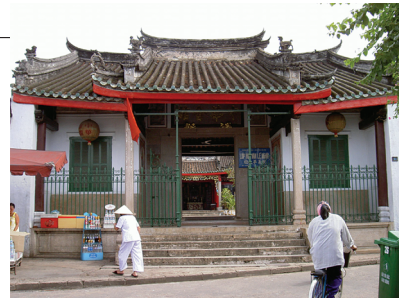
This Chinese style building was constructed in 1741 through the co-operation of traders from 5 Chinese regions, Fukien, Trieu Chau, Quong Dong, Hai Nam, and Gia Ung. It faces the river as is characteristic of other Chinese assembly halls. Additionally the hall has an approach that links it with the river.

You can see a sharply warped up ridge in the roof frame of the gate building, which is peculiar to Fukien houses.

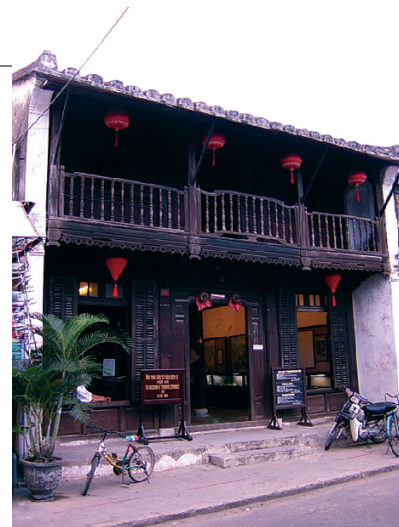
This is a representative two-storey house with a wooden balcony that was probably built in the 1920's.

As you enter the house you can see that the columns at the forefront of the house are either square or round. The floors are high, spans are large, and there are glass windows. Here, it is possible to see the typical space composition of residential buildings in Hoi An which are characterized by three consecutive buildings, a front building, a back building and a small building connecting the two. A courtyard is located between the front and back buildings and the kitchen and a toilet are behind the back building. On the second floor you can see the roof style peculiar to Vietnam which is called "Keo chong". It is in a triangular form made of two angled wooden members joined together at the top. The woods in this type of roof are richly decorated, and most of them have must be manufactured by machine.

Houses of this type can be seen extensively along the Nguyen Thai Hoc Street. This was the first house in Hoi An to be restored using modern techniques. It was restored in 1994 and since then it has been used as The Museum of Trading Ceramics. The museum displays some of the ceramic treasures found during excavation works in Hoi An, and they show the strong influence of Islamic, Chinese, and Japanese cultures.

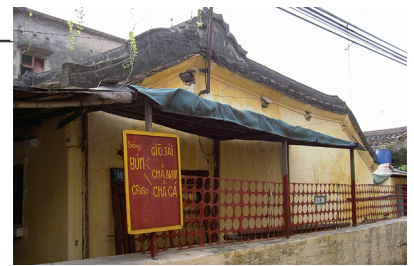
This house was transferred from the suburbs. At that time, the base of the supporting pillars were cut off, therefore, the height of house is lower than it would have been originally.

One of the characteristics of this house is the usage of relatively thinner timbers for the roof's structure.

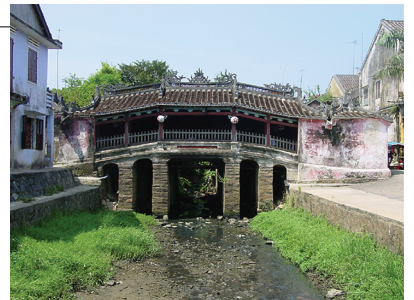
This bridge is one of the symbols of Hoi An. Despite its name, the bridge is not built in Japanese style, and in fact there are very few covered bridges in Japan.

There is evidence that suggests the bridge was built in 1595, however, it has been remodelled several times since then. Although the most recent restoration was carried out in 1986, the bridge is already showing signs of deterioration. The piers have leaned and attached temple building has been falling away from the bridge. It is necessary to restore without delay, but there are many problems to be solved such as traffic conditions, and water pollution, before the restoration work can start.

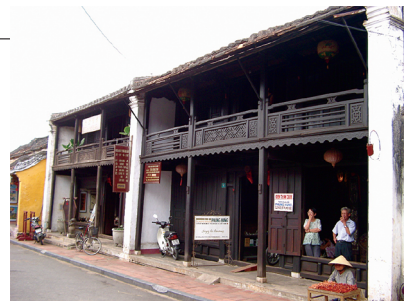
The houses at Nguyen Thi Minh Khai no. 4 and 6 were originally built as part of the urban plan of 1935. However, restoration work was undertaken separately, because their owners were different. While no.4 is owned by a private family, no. 6 is owned by the government and used as a public apartment house. It is interesting to note that there are some differences between the two regarding the application of restoration policies.

No. 6 was repaired under the principle of recovering the original features of a building as much as possible, while at no. 4 the wishes of the owners were taken into consideration. Therefore while the facade of no.4 has been equipped with a new hinged door, no.6 keeps the original style of sliding doors.

Today, in both houses the inner courtyard is covered by an extension of the roof, making the inside of the house larger.

Before restoration 修復前の状態
